TECHNICAL REPORT 4321

IN - BORE PREMATURE
MALFUNCTION INVESTIGATIONS
OF THE
81 MM HIGH EXPLOSIVE MORTAR CARTRIDGES
WITH THE
M526, M524A5 AND XM176
POINT DETONATING FUZES

FEBRUARY 1972

PICATINNY ARSENAL
DOVER, NEW JERSEY

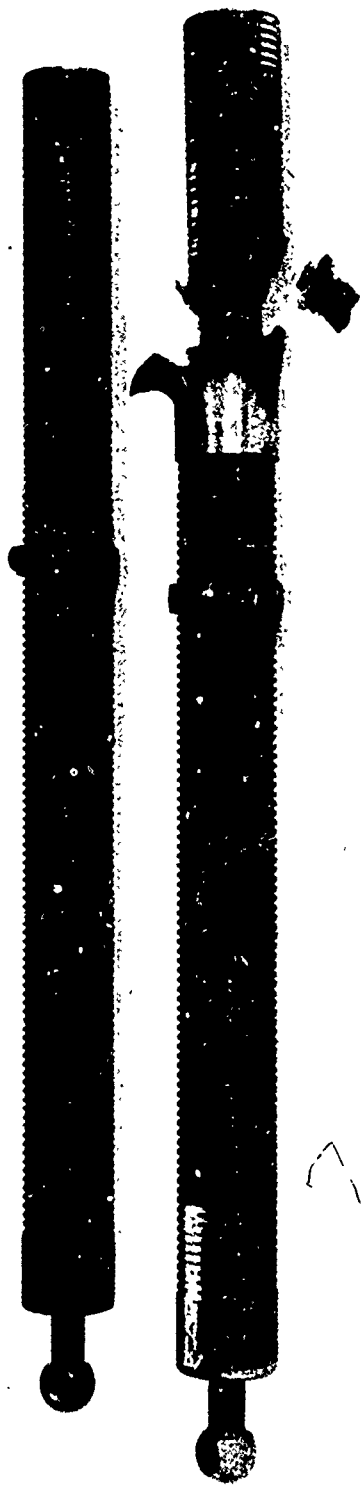
Voids in the HE Filler Near the Base -- An in-bore premature occurred at Jefferson Proving Ground, during an acceptance test of an M374 Cartridge. The round was fired at Charge 9. An x-ray of the round, taken before the malfunction, indicated a large void in the HE filler near the base. Test rounds were specially prepared to duplicate the malfunctioned round, and fired at various charges. The test data (Table 2) confirms that an in-bore premature can occur with this condition at high charge. The fragments of the mortar tubes used in the tests are shown in Figures 7 and 8.

Figure 7. Mortar tube before and after premature functioning of test round with void in HE filler and fired at charge 11

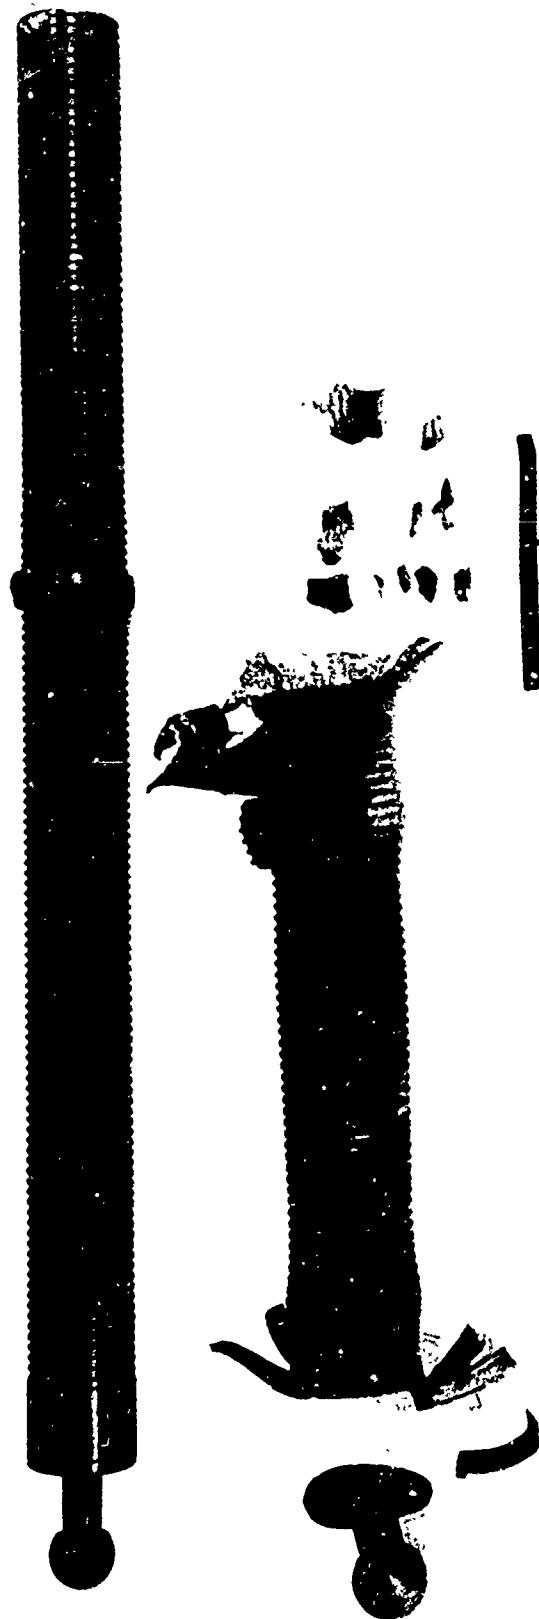
Figure 8 Mortar tube before and after premature functioning
of test round with void in HE filler and fired
at charge 12

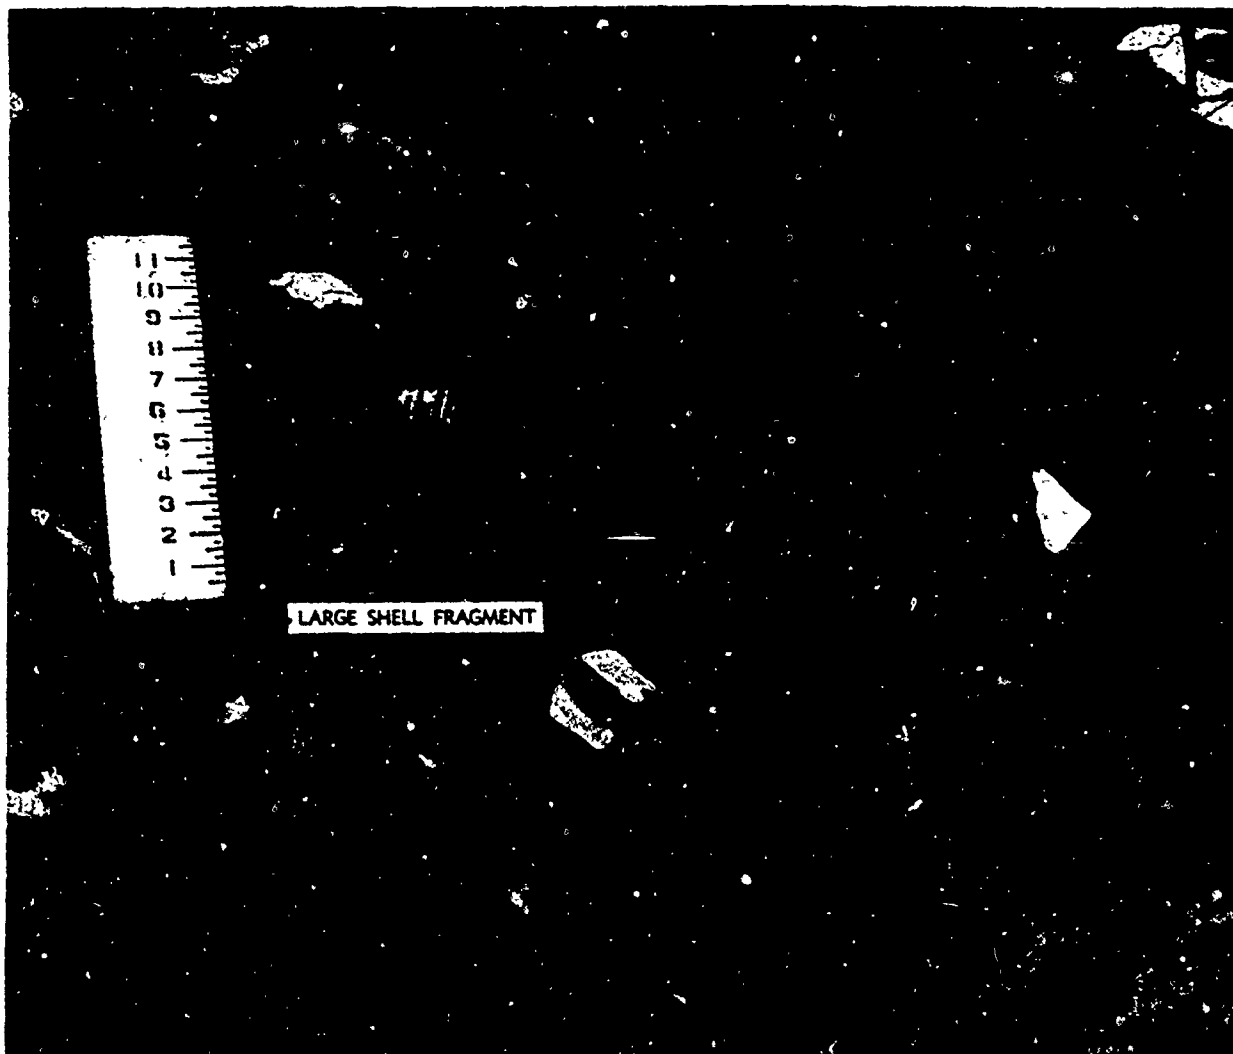
Figure 10. Tube and shell fragments from test round with holes through side wall of shell (side view)

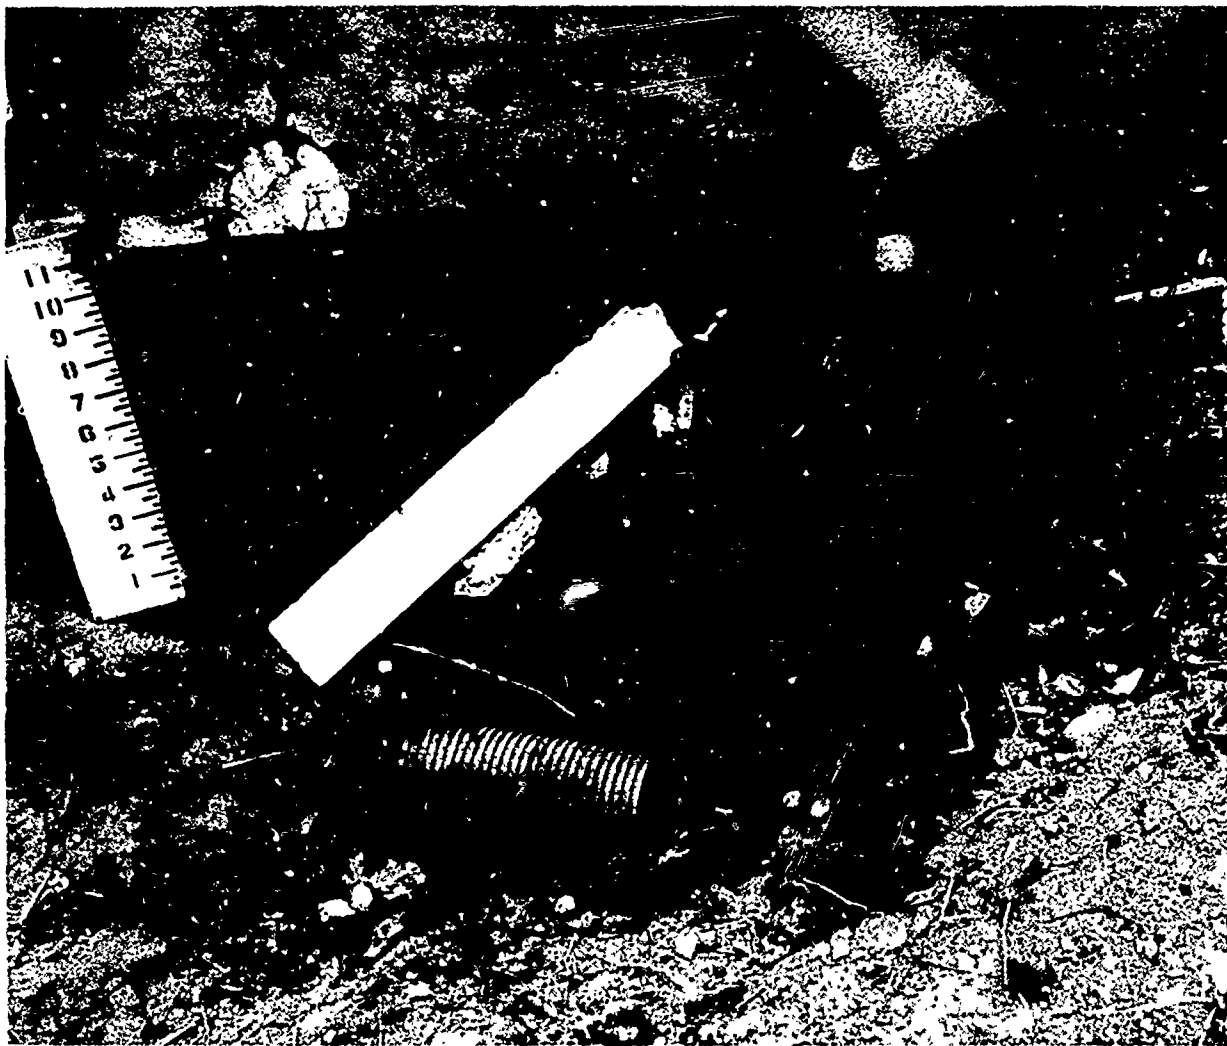
Figure 11. Tube fragments after premature functioning
of test round with holes through side wall of shell

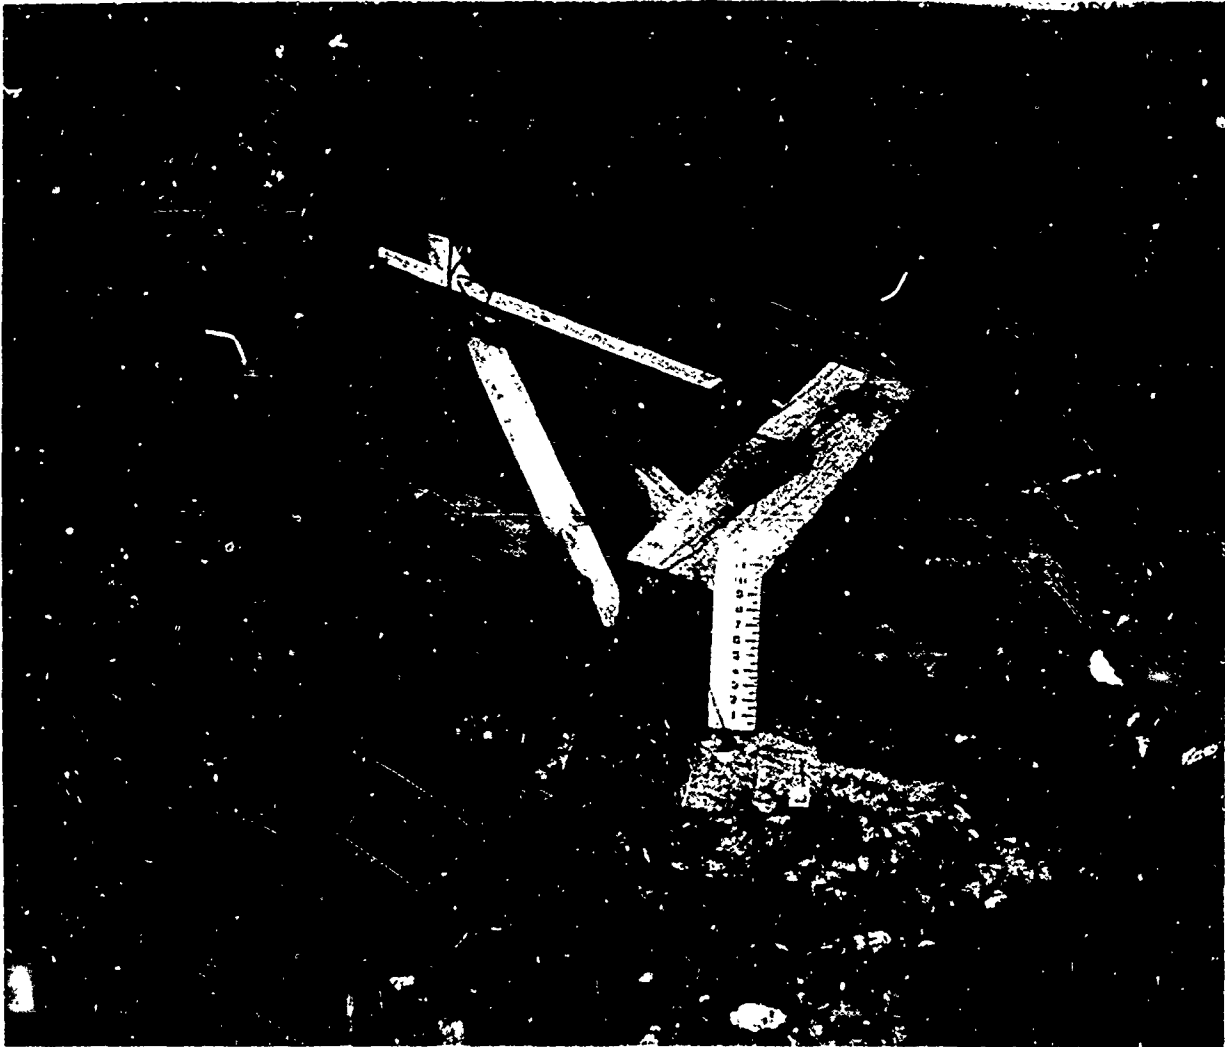
Loose-Fitting Base Plug in Cast Shell Body of the M374 Cartridge -- Previous tests, conducted with a low propellant charge, indicated that the HE filler in 81mm mortar ammunition cannot be initiated by propellant gases in the weapon as a result of loose-fitting base plugs (Reference 4). Additional tests were conducted by the Ammunition Maintenance Engineering Division by preparing sample rounds with loose-fitting base plugs. All rounds were HE-loaded and assembled with dummy fuzes. The test data indicated that a loose fitting base plug is a more serious defect than 1/16-inch holes through the shell base and will cause in-bore prematures (Table 3).

Figure 12. Tube fragments after premature functioning of test round with holes through base of shell

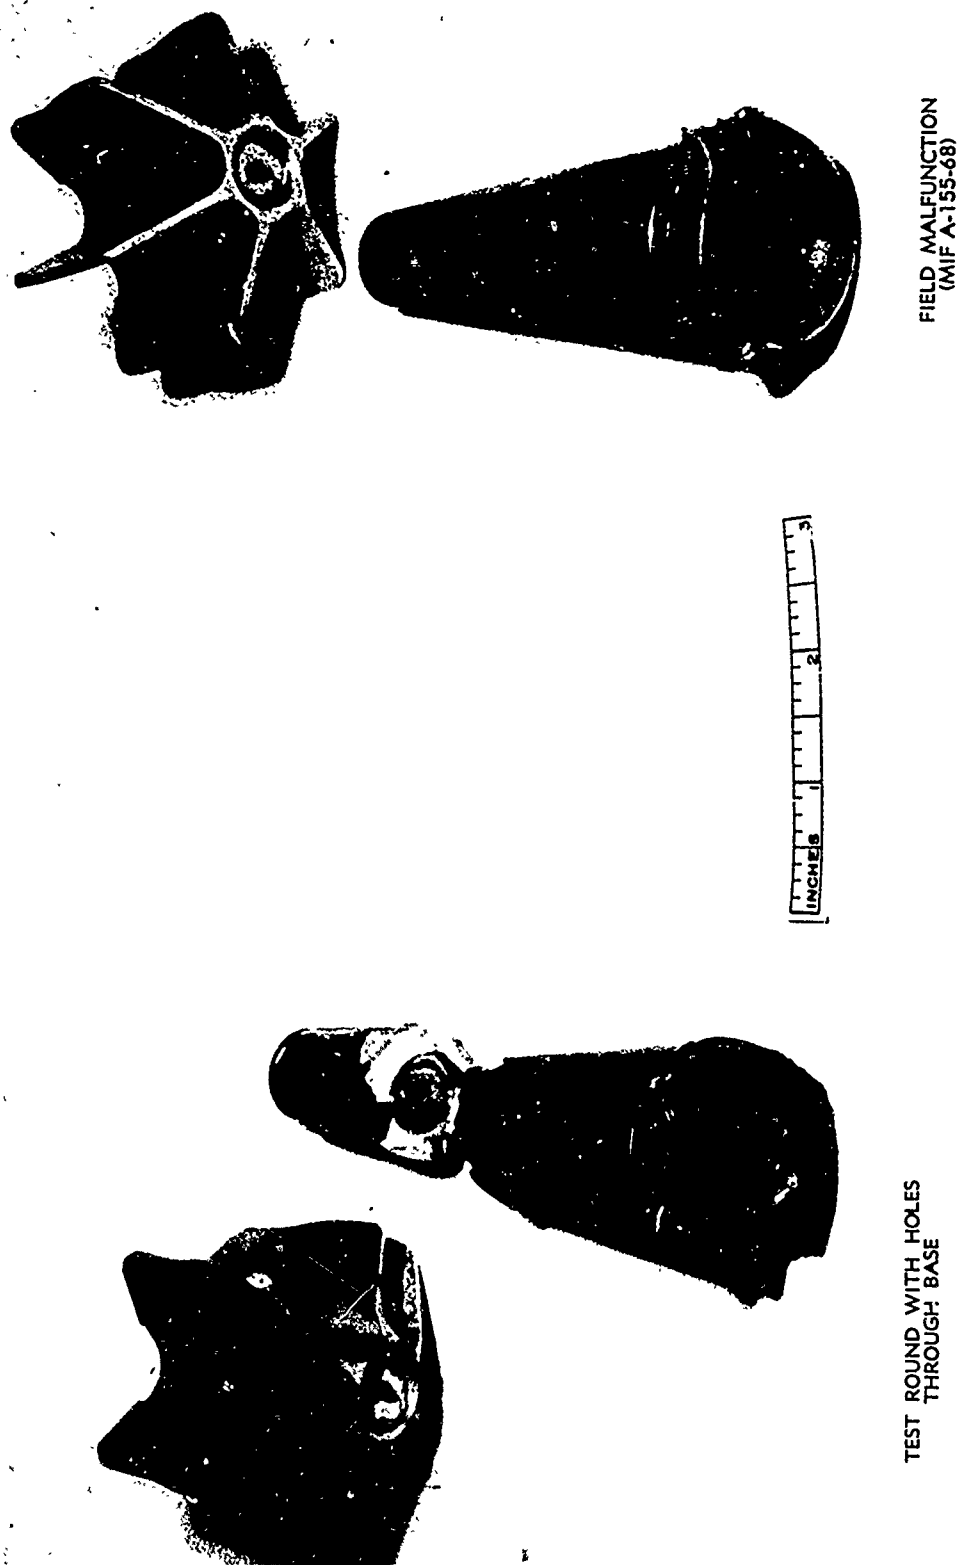
Figure 14. Large fragments from base of shell and fin assemblies

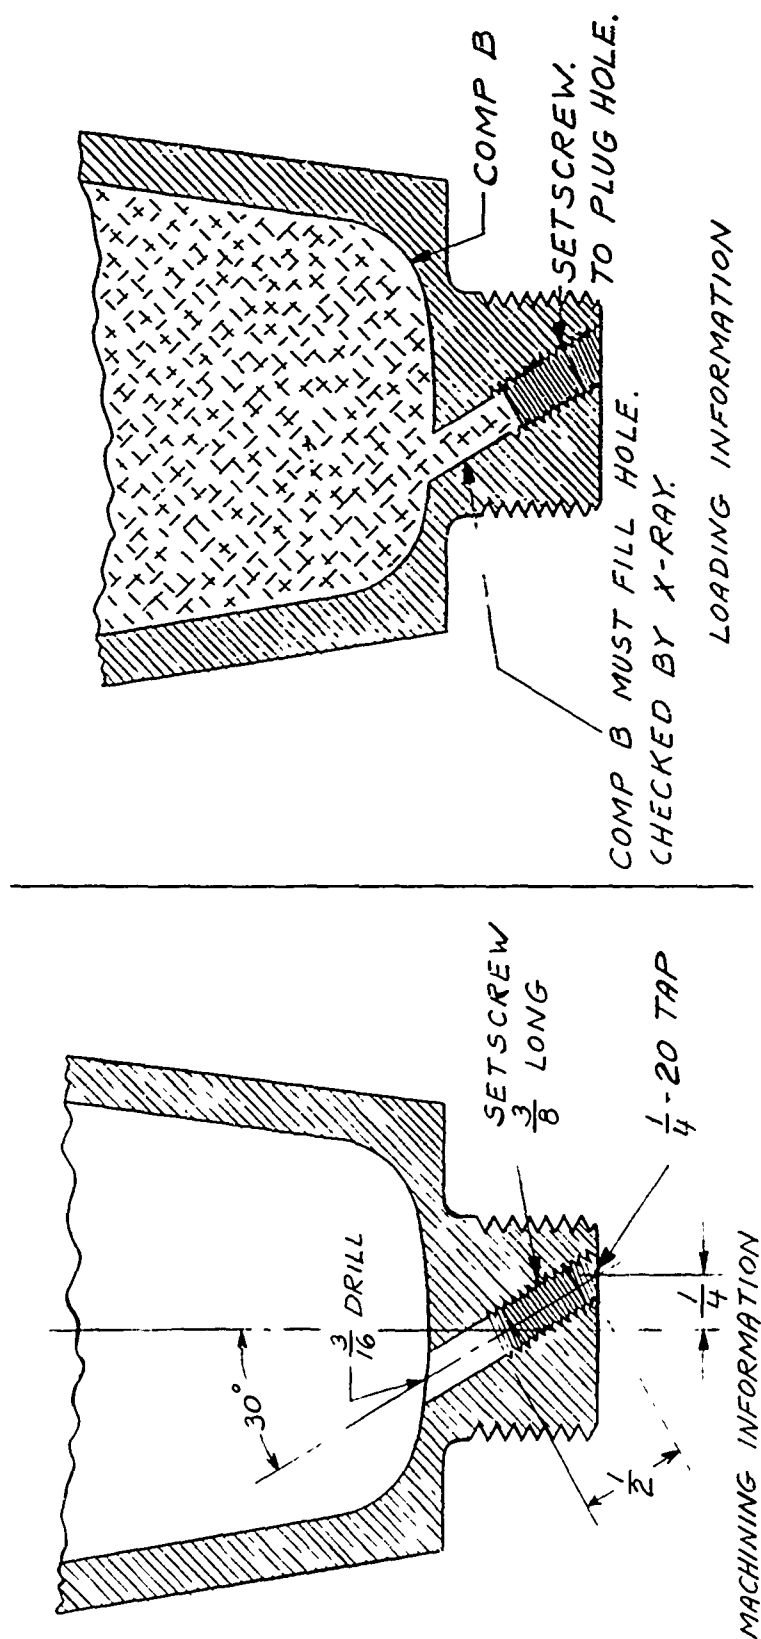
Cavity in the Inside of the Shell Body at the Base -- 100 sample rounds were prepared by drilling a 3/16-inch diameter hole into the inside base of the shell body, approximately 3/8-inch deep, 30° from the longitudinal axis (Figure 15) before loading with Composition B and assembling with dummy fuzes. All samples were x-rayed to assure that Composition B had filled the cavities. All samples were fired at Charge 9. The tests indicated that cavities in the inside wall of the shell body did not cause the HE filler to be "pinched" -- when setback forces were developed during ignition -- sufficiently to cause an in-bore premature.

Figure 15. Test rounds prepared with cavity in the inside of the shell body at the base

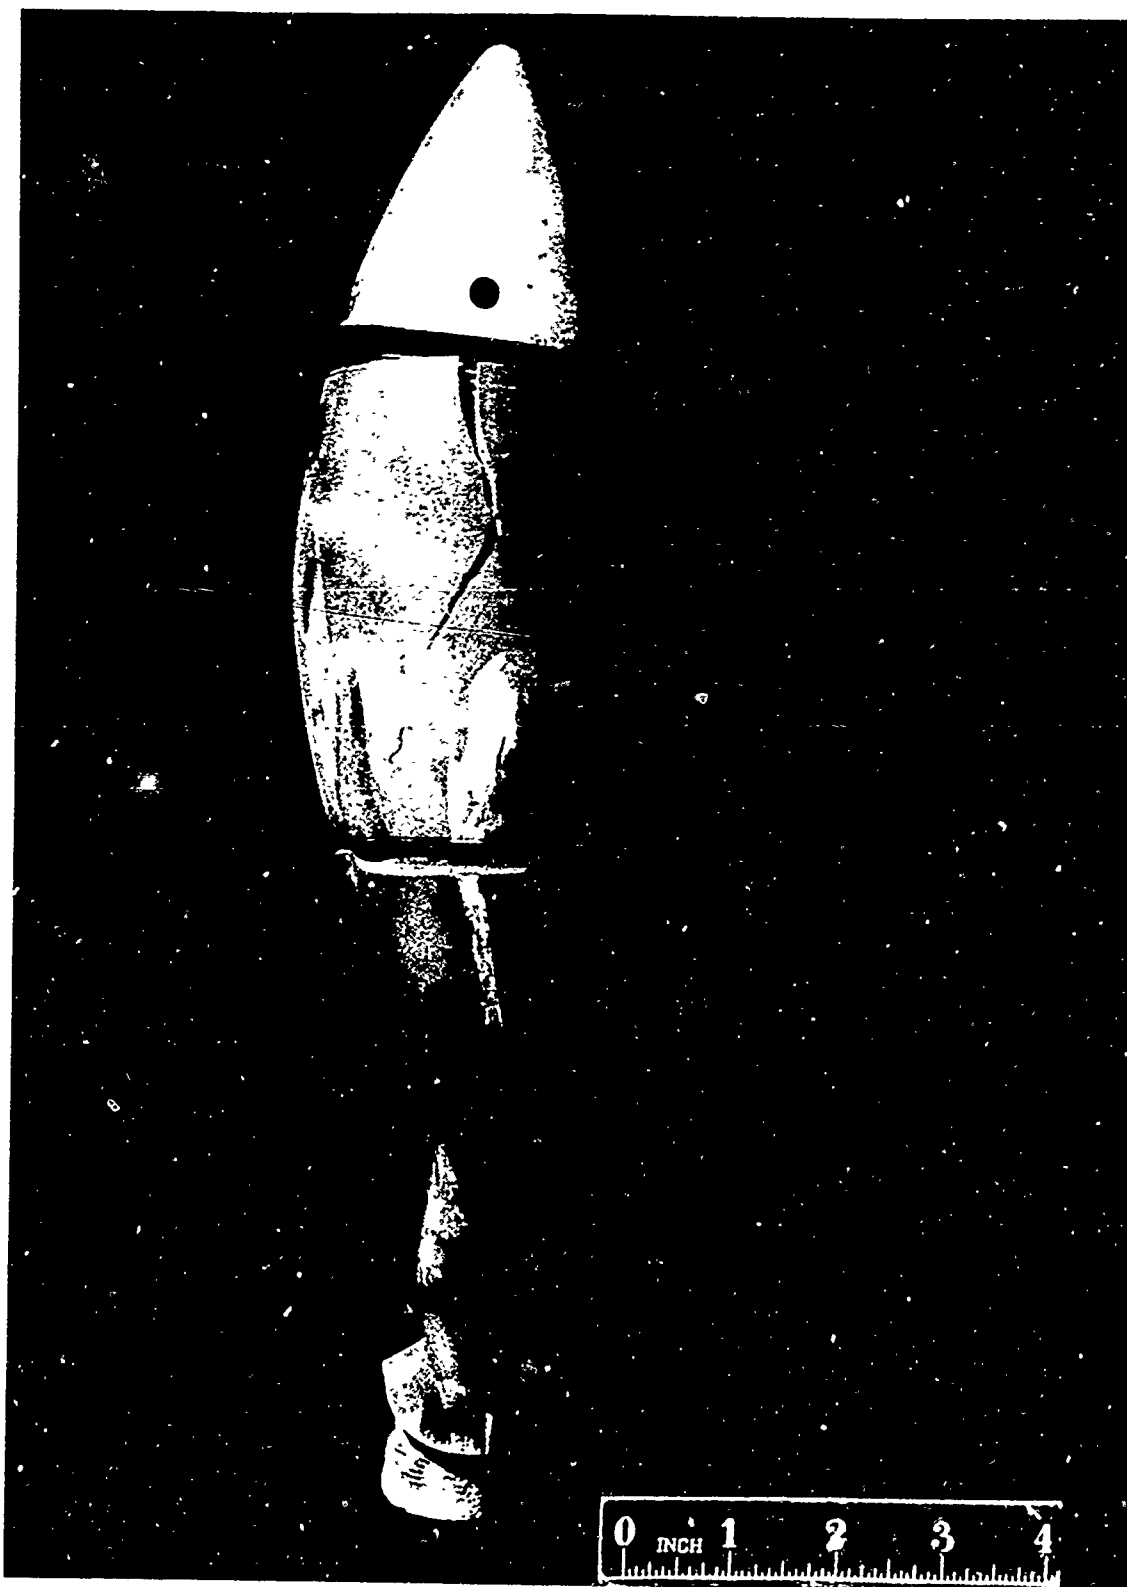
Figure 18. Bottom round from double loading (inert)

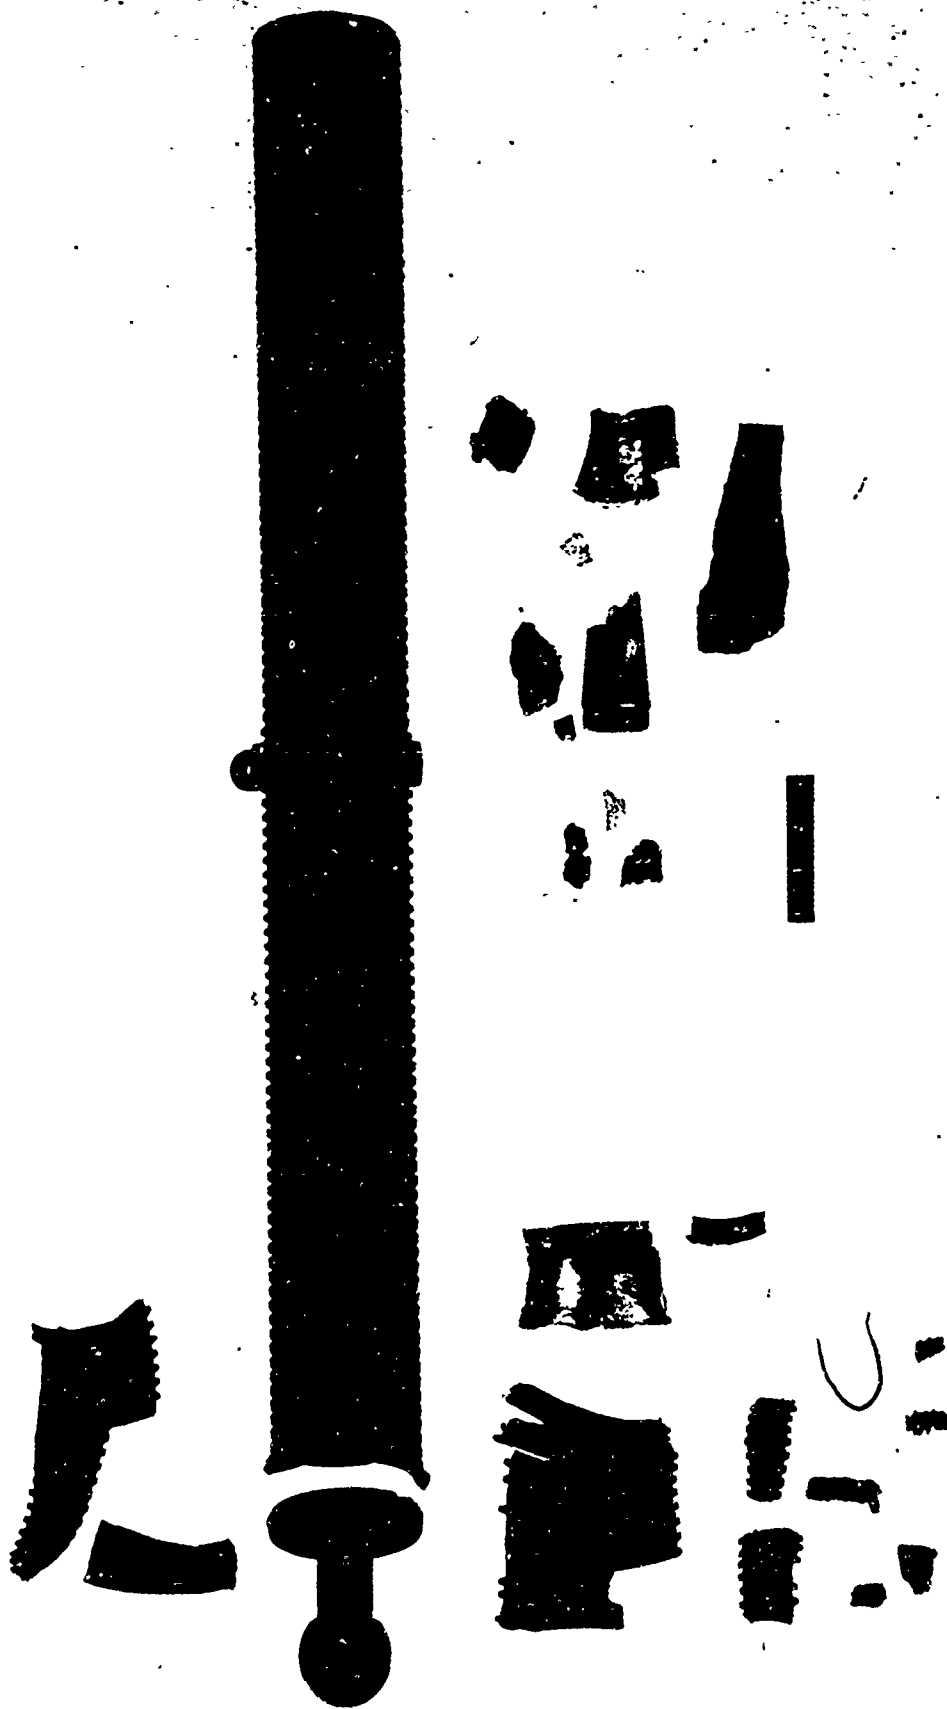
These incidents are evidence that double loading is a significant factor in the in-bore premature rate experienced with 81mm mortars. Tests were conducted to determine under which conditions double loading would cause an in-bore premature (Table 8). The test data indicated that fuzes with a rivet head protruding above the striker will probably cause a low order, in-bore premature (Figure 19) at a rate of 1:1 if the ammunition is double loaded. Fuzes with the rivet head flush with the striker, or no rivet on the striker will probably not result in an in-bore premature.

Figure 19. Tube and shell fragments from double loading test of HE ammunition

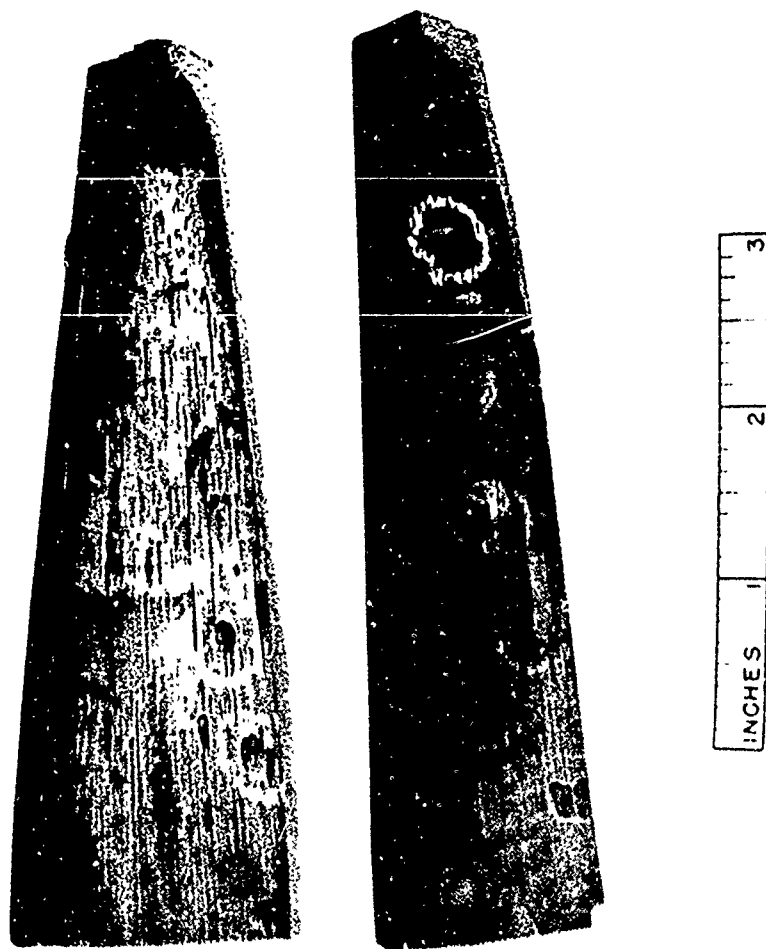
All projectile samples, including factory rejects, were tested for Rockwell hardness (Table 10) and x-rayed along the longitudinal axis. A minimum of 40 samples from each lot were x-rayed twice, 90° apart. There were no cracks in the shell or voids in the HE filler. Some x-rays showed dark spots which indicated thin material in the wall of some shells. The thin material (pits) also were detected in the ultrasonic test. A cutaway section of a shell showing pit marks is in Figure 20.

Each shell was subjected to an ultrasonic test. The pits observed in x-rays were recorded in these tests. The pits measured from 0.021-0.032 inch deep. The wall thickness adjacent to the pits measured 0.208-0.212 inch thick.

Figure 20. Sections of shell bodies with pits on inside surface

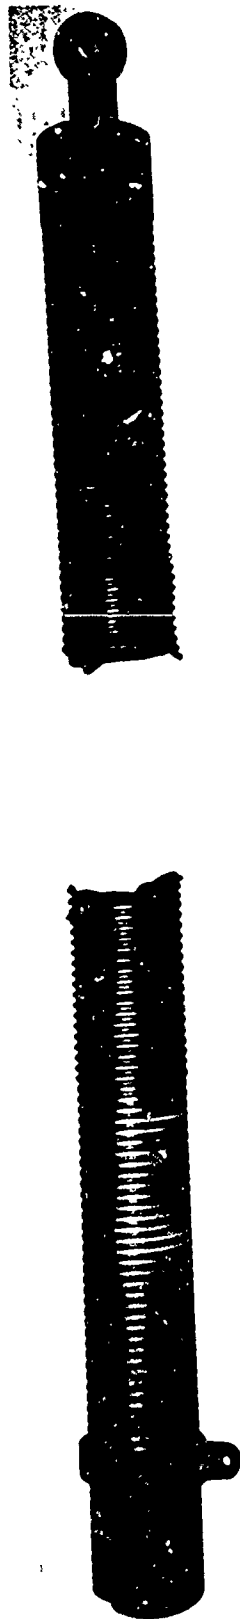
Figure 22. Fragments of tube involved in in-bore premature malfunction (MIF A-155-68)

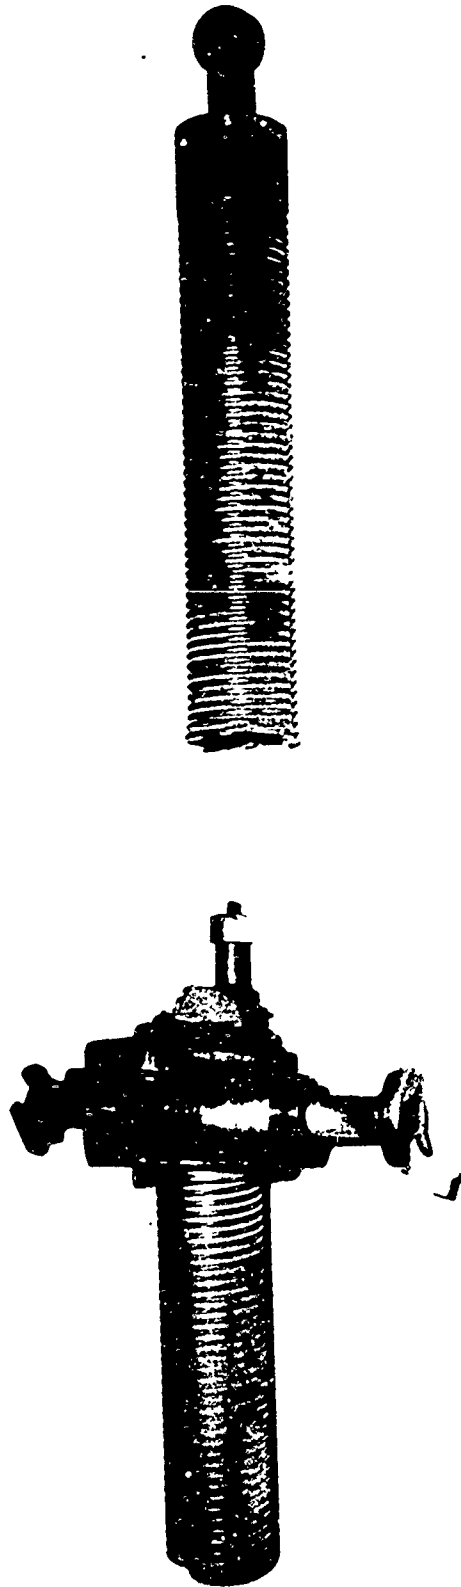
Figure 26. Fragments from tube involved in in-bore premature malfunction (MIF A-41-69)

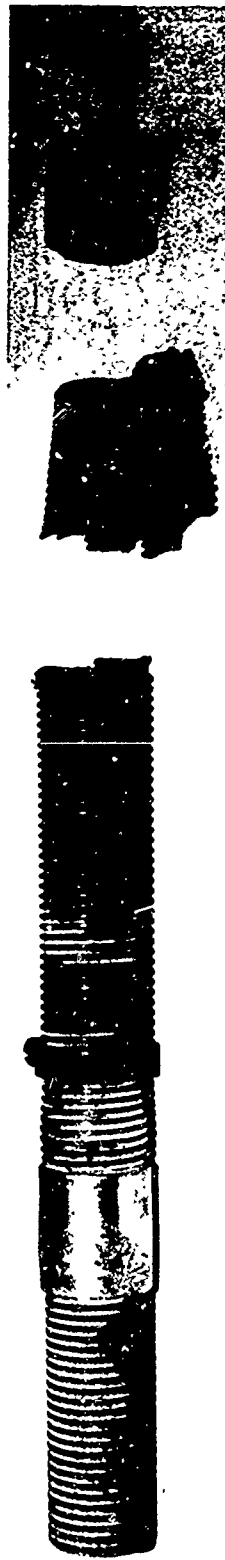
Figure 29. Fragments from tube involved in in-bore malfunction (MIF A-129-70)
